Fort Trumbull, New London, CT Constructed between 1839-1852

Visit Wednesday July 21, 2021

Report by Mary Gage with input from James Gage
Photographs by James Gage
Historic images and reports tracked down by James Gage
July 29, 2021

1794 Block House

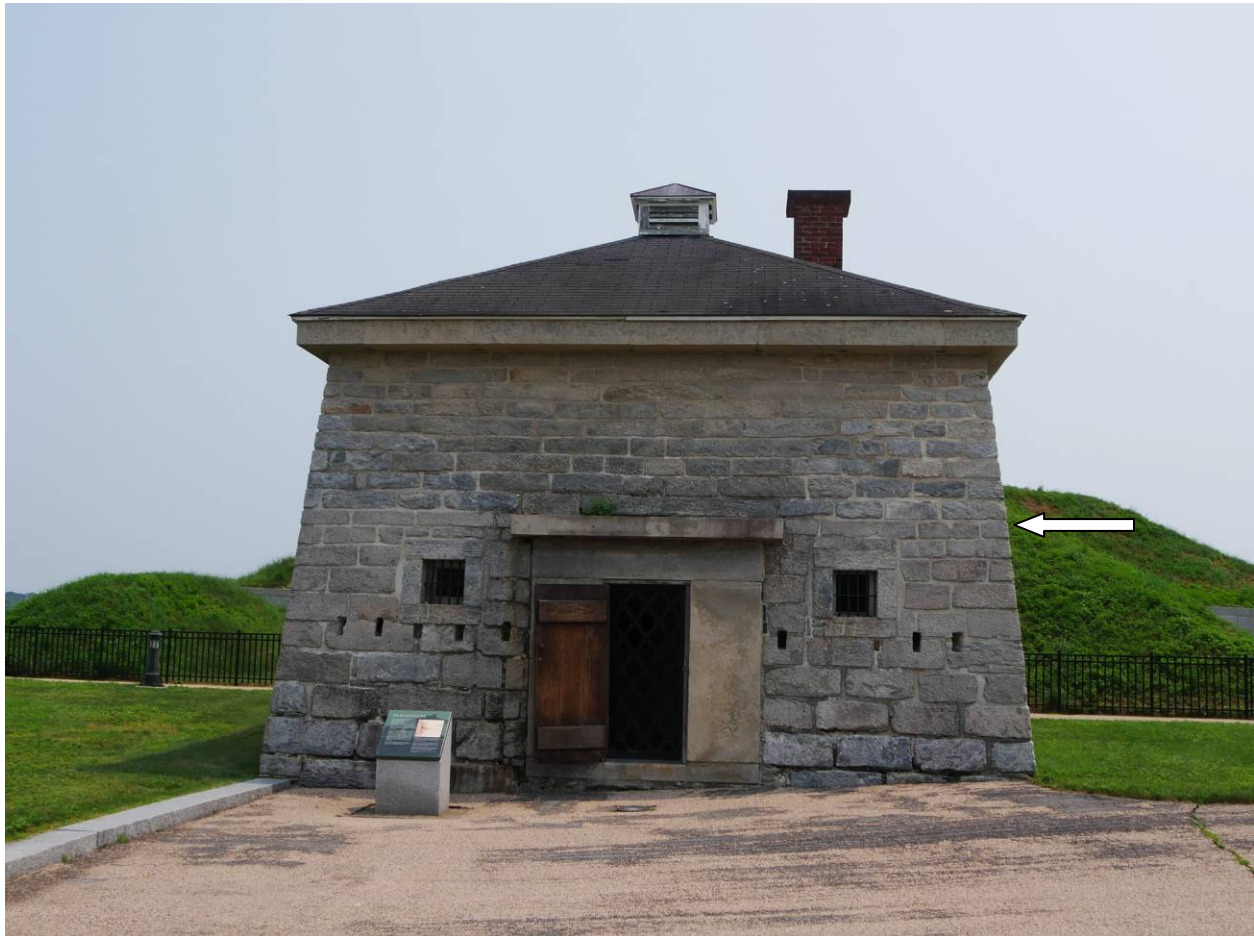
The bottom half of the block house is a little higher than the actual halfway mark. It is almost at the 2/3's height mark. In figure 1 the top of the current entrance is at the same level as the top of the bottom half and marks the original height of the block house. At that point there is a change in the type of stone indicating the upper section is an addition.

Figure 1 – West side of block house with entrance. The top layer of the original 1794 block house is indicated by the arrow. It has the same height as the entrance.

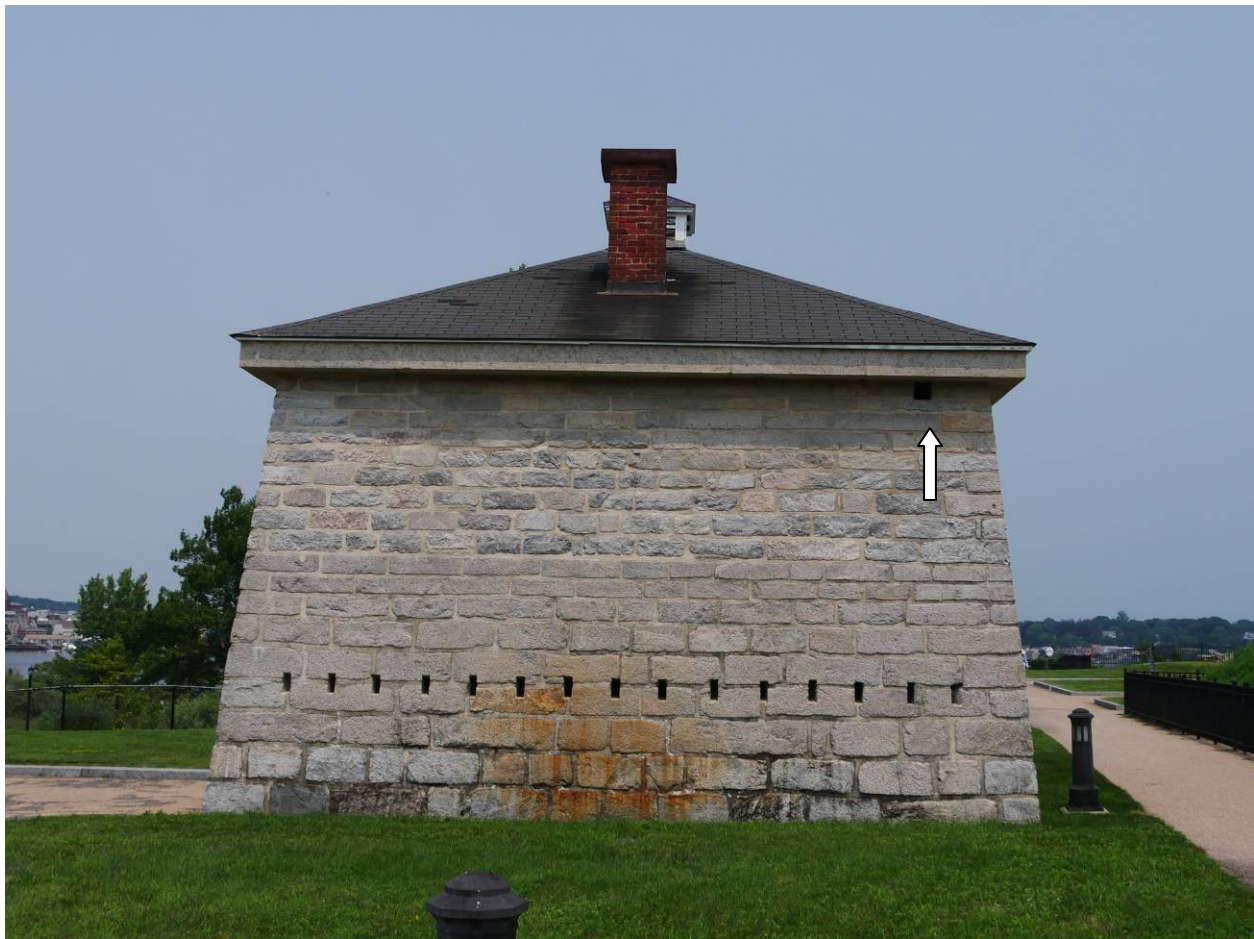
Small rectangular openings between layers 5 & 6, evenly spaced out across whole width of building. Total of 15 in the south wall. (Figure 2)

Figure 2 – South side of block house with fifteen gun ports and a vent hole in the upper right below the stone eave of the roof (indicated by the arrow).

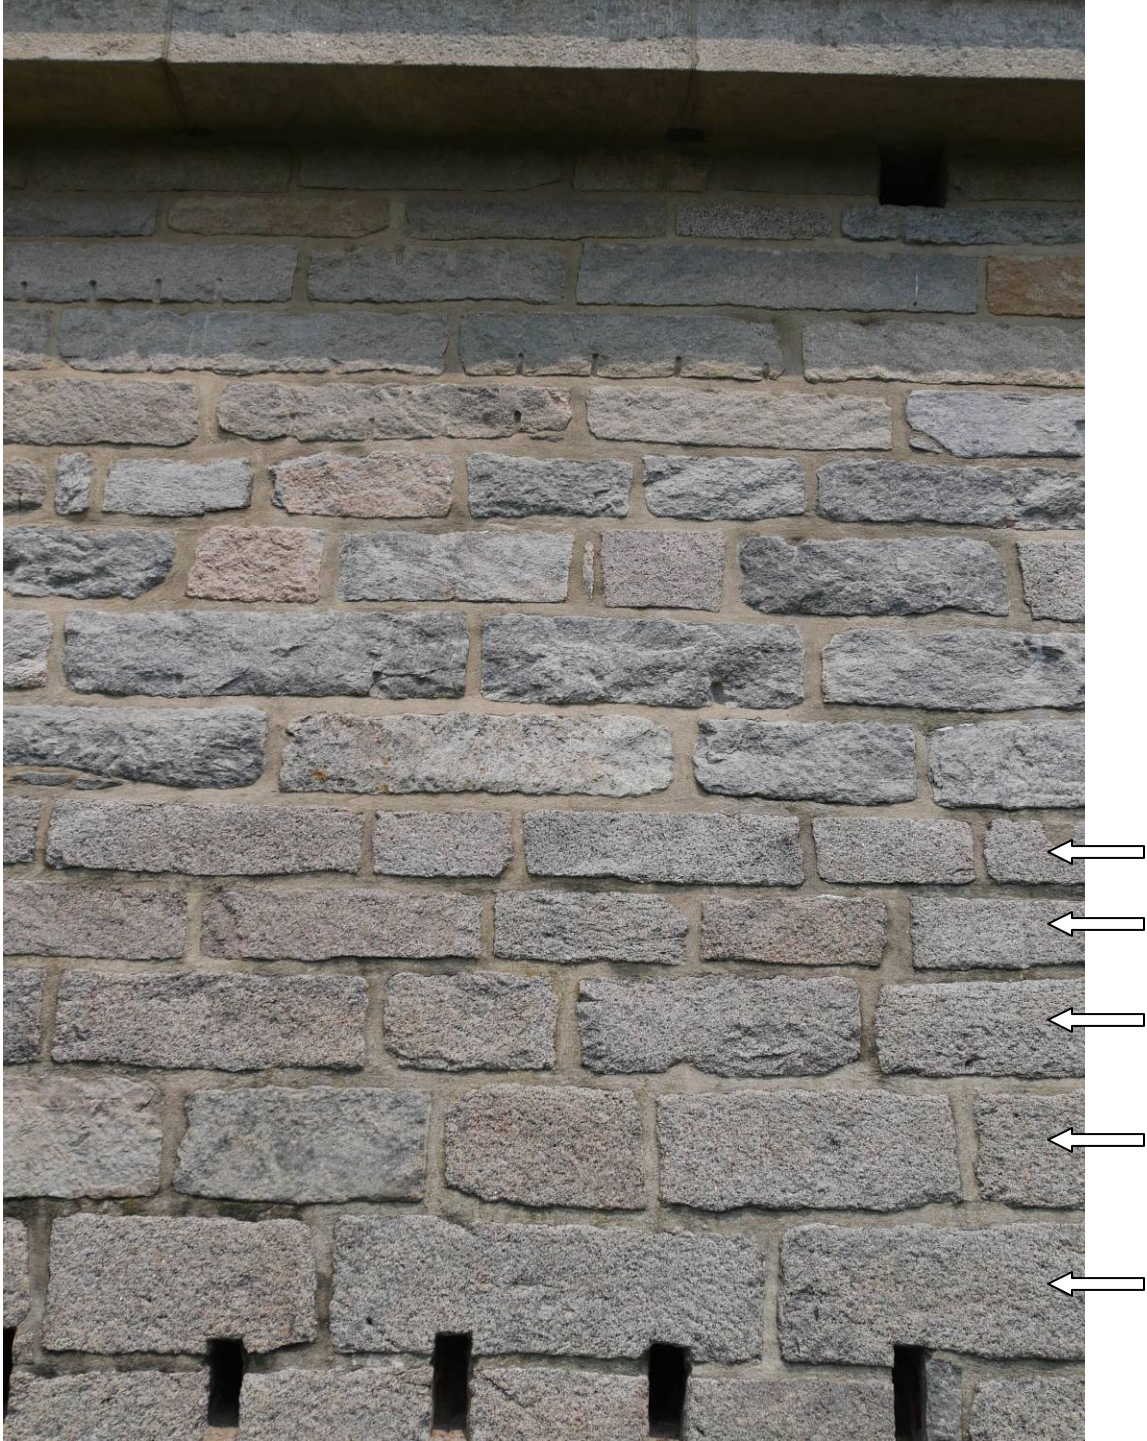
Uniform color and texture of pinkish-tan, same type of stone (bottom half of figure 3)

Figure 3 – Close-up of south wall. Note the uniform color (pinkish-tan) and surface texture (semi-smooth) of the stones in the lower half of photo (arrows). It is different from the blue-gray color and rough surface texture of the stones in the layers above it.

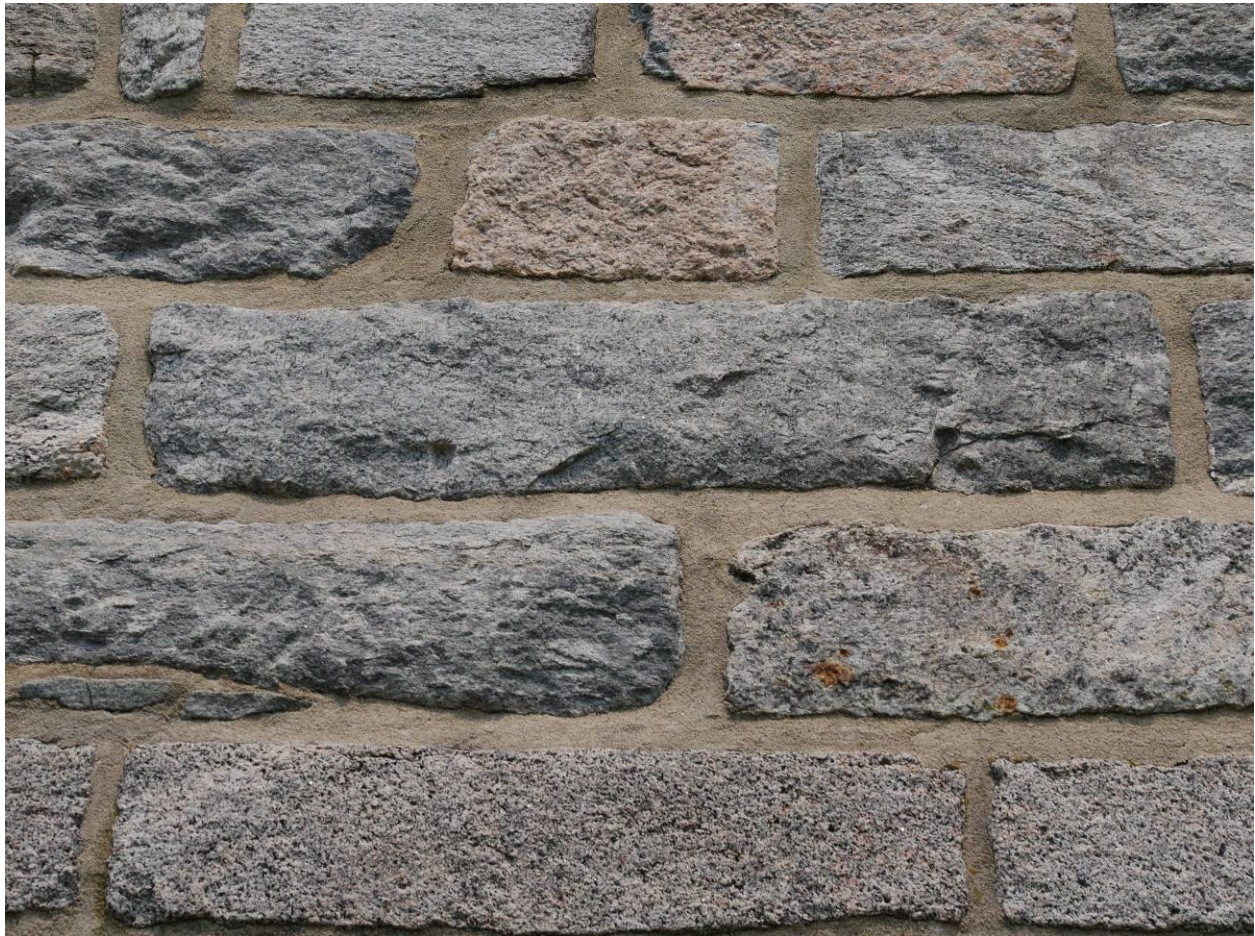
Compare stones in lower half with stones in upper half. There is a marked difference in the finish. In figure 4 the bottom row shows a layer of stones from the bottom half with a semi-smooth flat face whereas the upper rows have a rough uneven finish.

Figure 4 – The bottom layer in this photo is the semi-smooth pinkish-tan color of the original 1794 block house stonework. The rough stones in the three layers above of it are part of 2nd phase which involved repairs and additions made to the building.

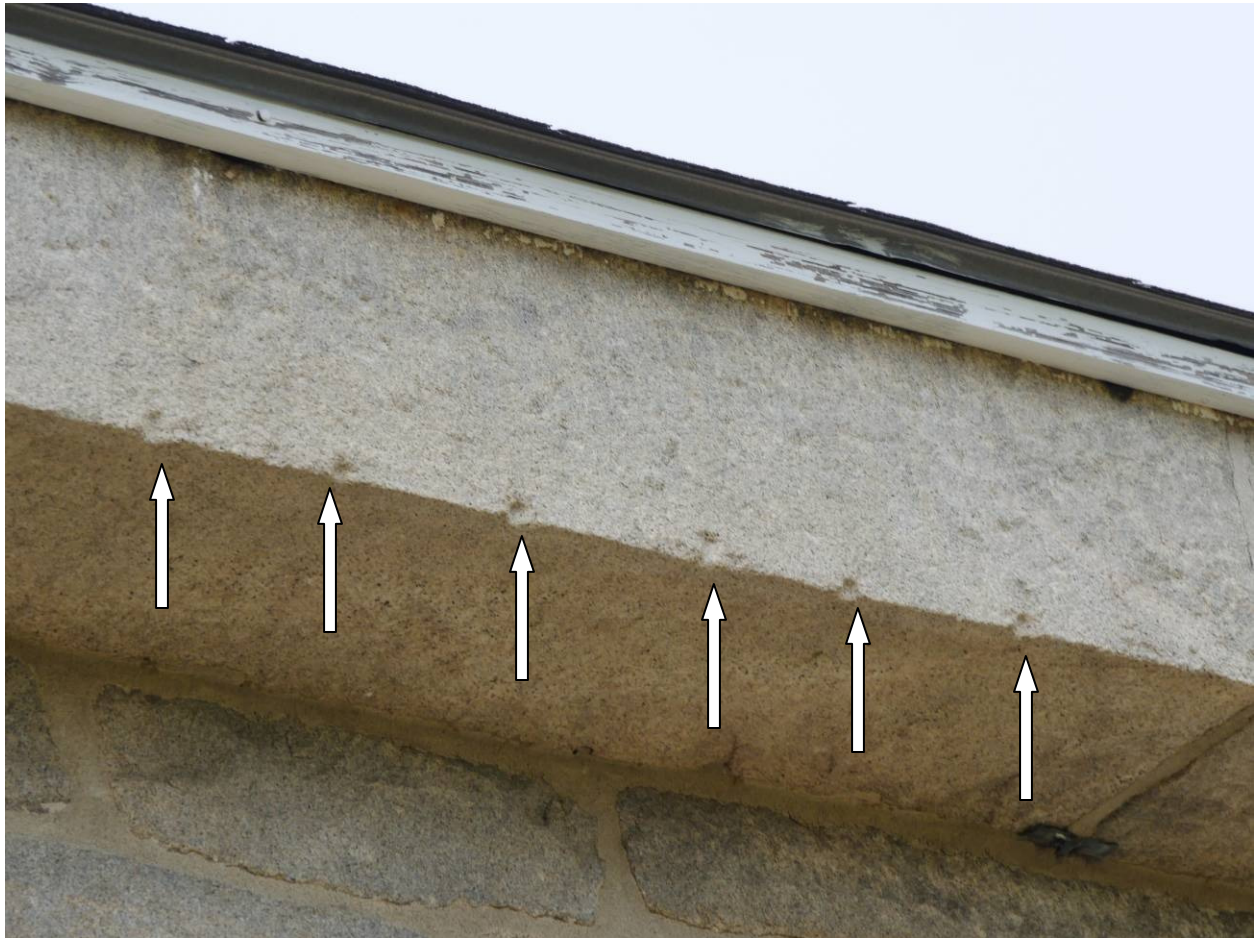
The eaves of the roof are constructed of high quality well finished stone slabs which are similar to the stonework used in the current Fort Trumbull (1839-1852). Commercial plug and feather method drill holes are present on at least one of the slabs. That dates the roof to post 1820 and is consistent with the 1843 and 1848 repairs and bomb proofing of the building. (Figure 5)

Figure 5 – The roof eave stone on the east side of the block house has the same color and smooth finish of the stones in Fort Trumbull. Remnants of drill holes from the commercial plug and feather method of splitting the stone are visible and indicated by arrows. This phase of repairs and renovations dates from the 1840s.

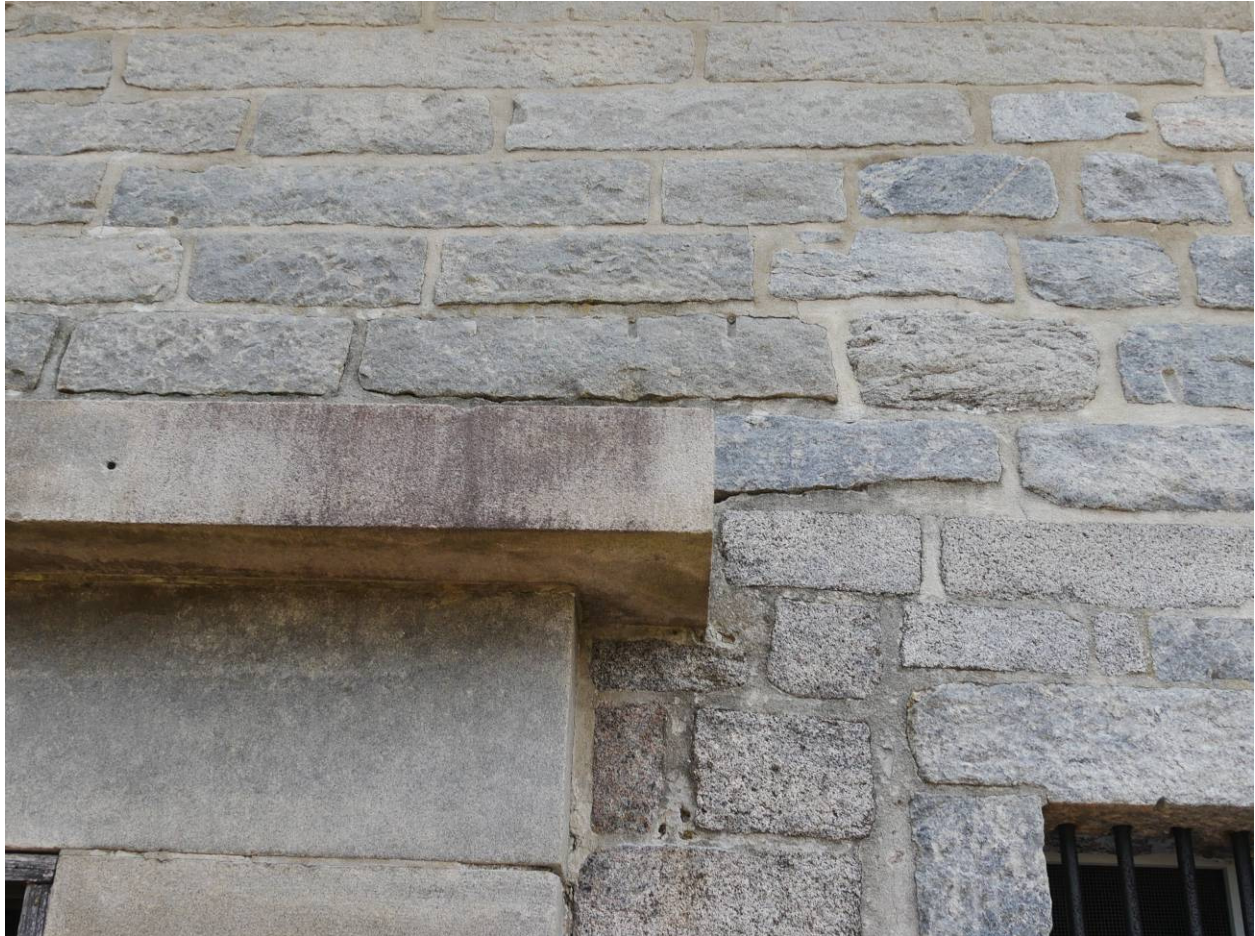
Compare the stone finishes in figure 6. This photo shows stones from three different periods.

- Bottom left corner stone is completely smooth with a high quality finish
- Top left corner stone has a rough uneven finish
- Center (right) of the smooth, finished stone is the semi-smooth stone (phase 1)
- Bottom right corner stone framing window has a different texture than semi-smooth stone above it. It has a flat face but does not exhibit a smooth finish.

Figure 6 – Close-up of the stonework on the west side. The stonework of the entrance is in the lower left of the photo.

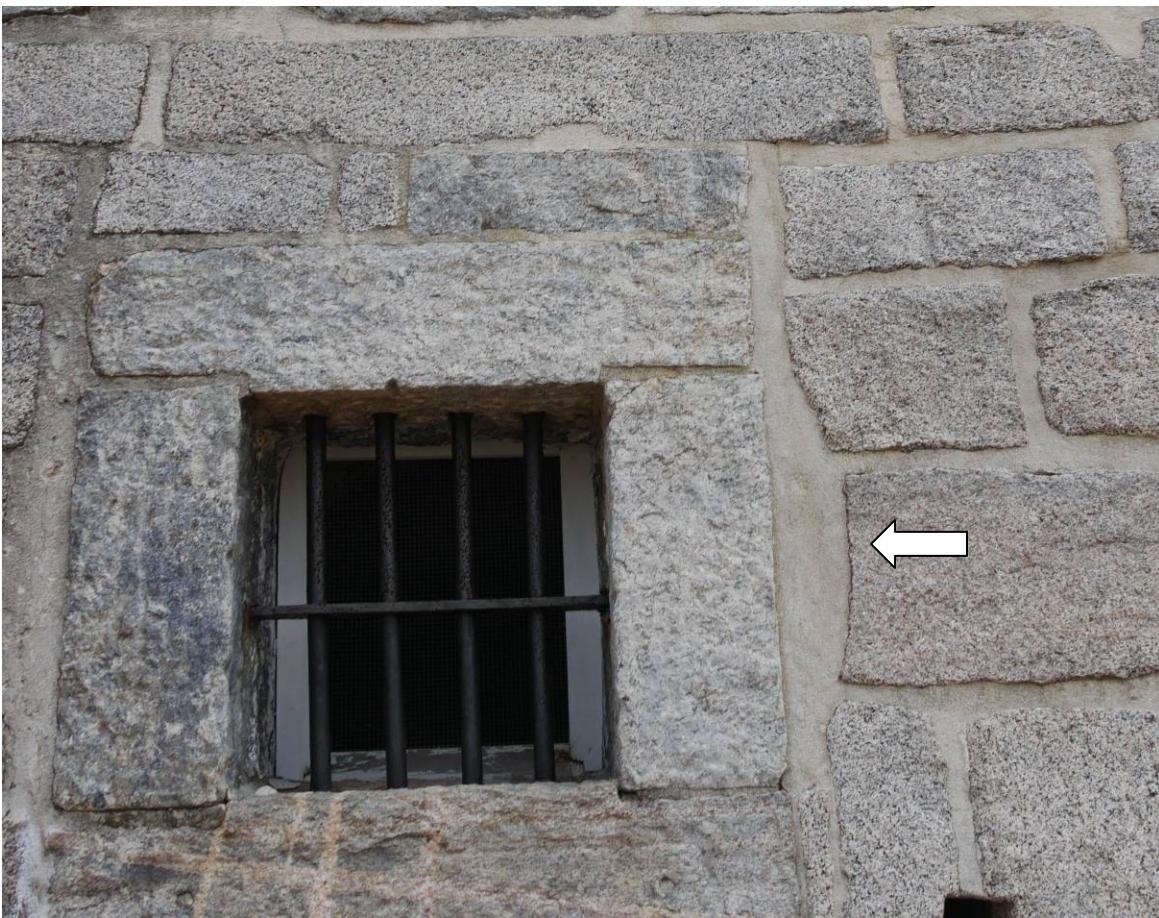
The two small square windows flanking the entrance proved to be an interesting study. They are framed with stone blocks similar in texture, finish and color to the stones in the wall. Their stone frames were made to blend in with the existing stones. A closer look shows the horizontal top and bottom bars were fitted that is they have an extended narrow edge on the window side. The narrow edge fits between the two vertical side bars like a puzzle piece. Small finish details like this were found in the masonry work at Fort Warren 1833 -1861 in Massachusetts. It seems to be a common aspect during this time period. Yet it is in contrast to the stark plainness of the door frame. A completely different style.

In addition, these windows have an unusual feature. Note the crescent shape of cement on each side of the vertical bars. The wall stones abutting are curved (concave) forming to the crescent shaped cement. That shows there were originally two circular windows flanking the door. The west side windows shape matches the large circular opening in the north wall indicating it was originally a window. During the building of the fort that included repairs to the block house, the old circular windows were replaced by the small square windows.

Figure 7 – This photos show details of the window on the right side of the entrance. The arrow points to crescent shape cut to accommodate the original round windows. There is a matching crescent shape on the left side of the window.

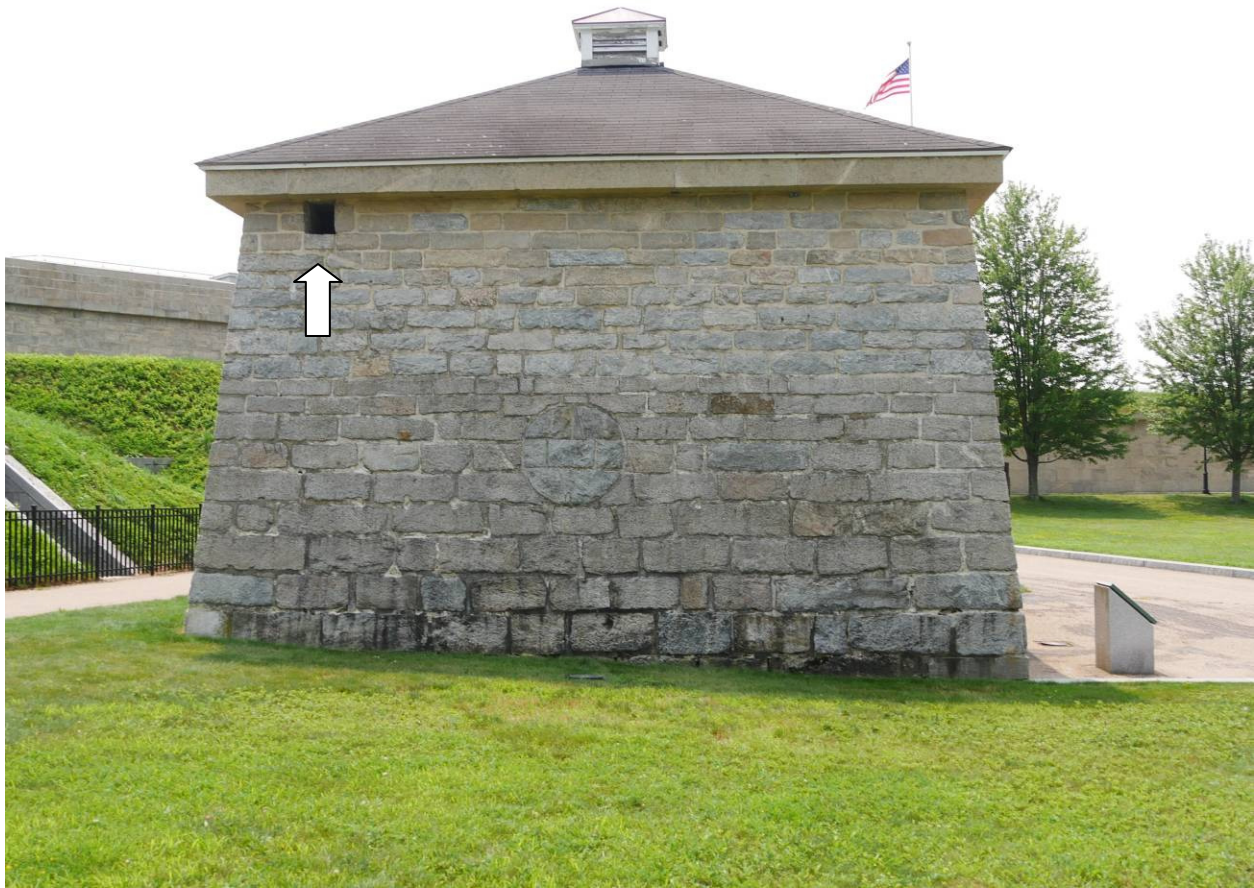
Figure 8 – Overall view of north wall. Arrow indicates vent near top of roof under the stone eave.

A single small square opening is in the top corner under the roof eave in north and south walls. (see figures 2 & 8) West and east side walls do not have the small opening. The openings appears to be for ventilation. The opening is shown in circa 1907-1915 postcard (figure 11). The current ventilator at the peak of the roof is not shown. It dates from later in the 20th century.

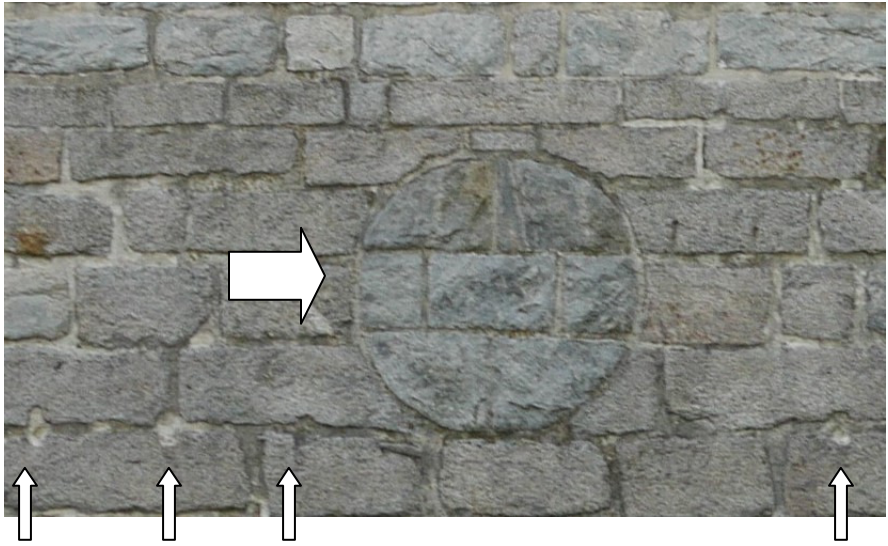
The circle's diameter is the height of 3½ stone layers. It starts at the bottom of layer 6 with the top part of the rifle ports and goes up to layer 9. What was the large circular opening's purpose? There is no evidence it was a gun port for a canon. At Fort Warren on George's Island in Massachusetts canon gun ports had slotted openings with an hour glass type shape flared out on interior, narrow opening and flared out on the exterior of the wall. The circular opening was on the north bay (water) side of the building. Its circular shape is similar to a porthole in the side of a ship. Was the large opening used for viewing the water for enemy ships as a lookout feature?

At an unknown date the circle was filled in with stone along with the rifle ports (on the north wall) that were filled in with cement. The filler stone has a rough finish similar but not quite the same as used in phase 2. It is also a little darker blue-gray than used in phase 2. Stones are tightly fitted, closer than in the any of the three phases used to build the wall. Gaps between the stones are very narrow to the point there is almost no gap which includes the outer ring. This is the work of a master mason who tightly fit the stones into the circular opening tightly sealing it up. The filler stones were chosen to match the stones in middle section of the wall suggesting it was done during one of the to repair dates (1843 or 1848).

The rifle ports in the stone layer at the base of the circular opening were completely filled in with cement. This sealed the bottom half of north side blocking out light and moisture.

Figure 9 – Large arrow indicates filled in circular window in north wall. Small arrows indicate filled in gun ports.
