## Stone Chambers: Root Cellars, Ice Houses, or Native American Ceremonial Structures?

Mary Gage and James Gage

*This article addresses the question of the cultural affiliation and purpose of the nearly 700 stone chambers found in northeastern United States by evaluating their architecture and construction methods.*

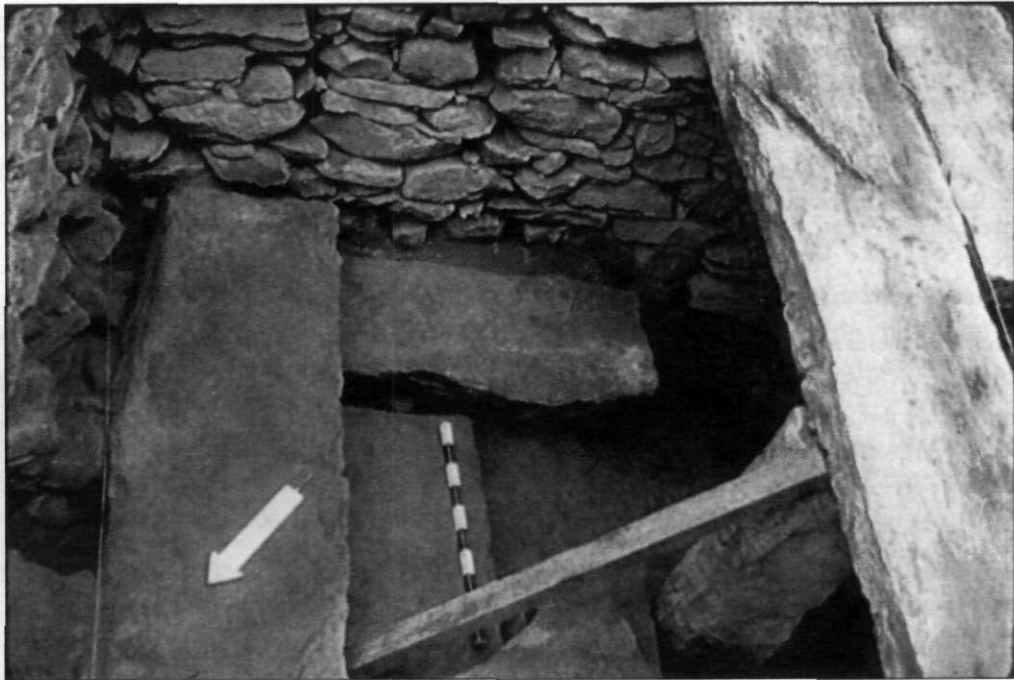
Figure 1. This circa 1823 root cellar was covered with a roof constructed of 14.5 foot long quarried stone slabs (now partially collapsed). Phoenixville, Eastford, CT (Photo used with permission of Old Sturbridge Village (P.83 VIIA Slide #27 Sept. '83).

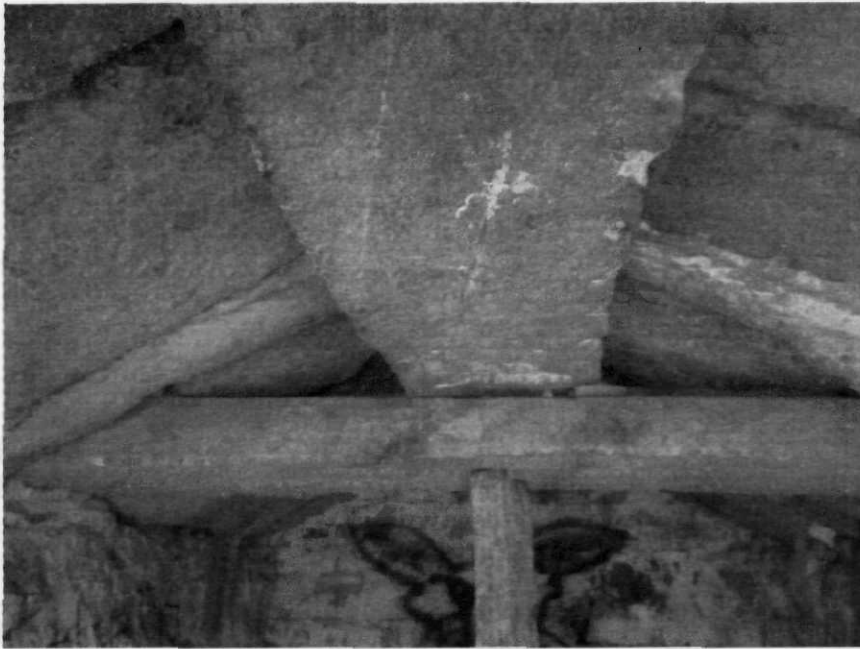
*Figure 3. Interior view of the Westford root cellar. The rectangular interior room is covered with a gable roof made from quarried stones supported by a stone ridge beam. (Photo courtesy of David Brody).*

This root cellar was built into a hillside. It was constructed of quarried stones from the Westford quarries located less than a quarter mile away. A short passage way formed by retaining walls on either side leads to a wide doorway (Figure 2). The interior is a rectangular room. A long stone bar was used as a ridge beam to support a series of stone slabs made into a gable roof (Figure 3). A stone post was used to provide additional structural support for the ridge beam stone. The angled sides of the gable would have helped to drain water off the roof away from the inside of the root cellar. This is the only known example of a stone slab gable roof. The stones were quarried with the flat wedge method, which dates it to after 1800 (Gage & Gage 2005: 41-42; Gage & Gage, 2013). (Description based upon photographs by David Brody.)

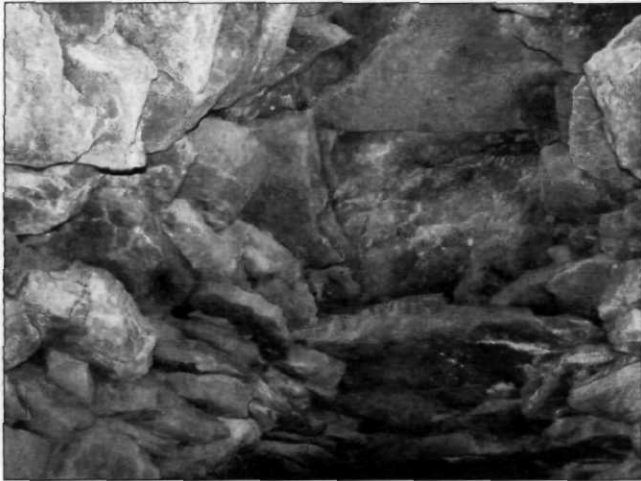
Figure 6. Fully corbelled chamber (dome roof), Rocky Brook Stone Chamber, Thompson, CT.

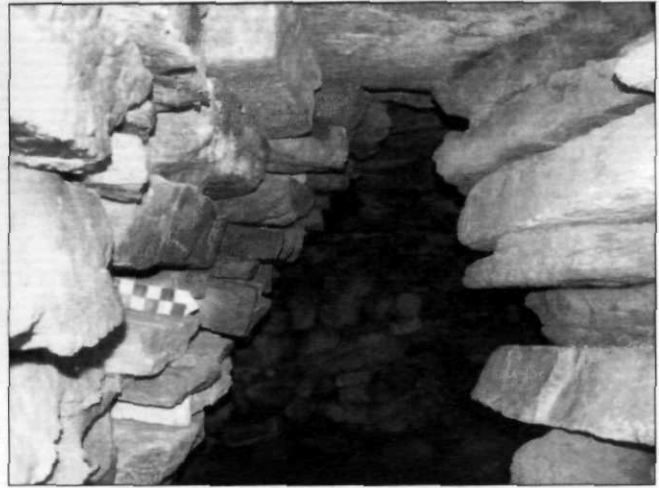
Figure 7. Corbel to stone slab roof construction, stone chamber, Webster, MA.

the width between them. This narrow width is spanned by a series of flat stone slabs (Figure 7). The purpose of the corbelling is to reduce the length (and weight) of the stone slab needed to span the distance between the walls.

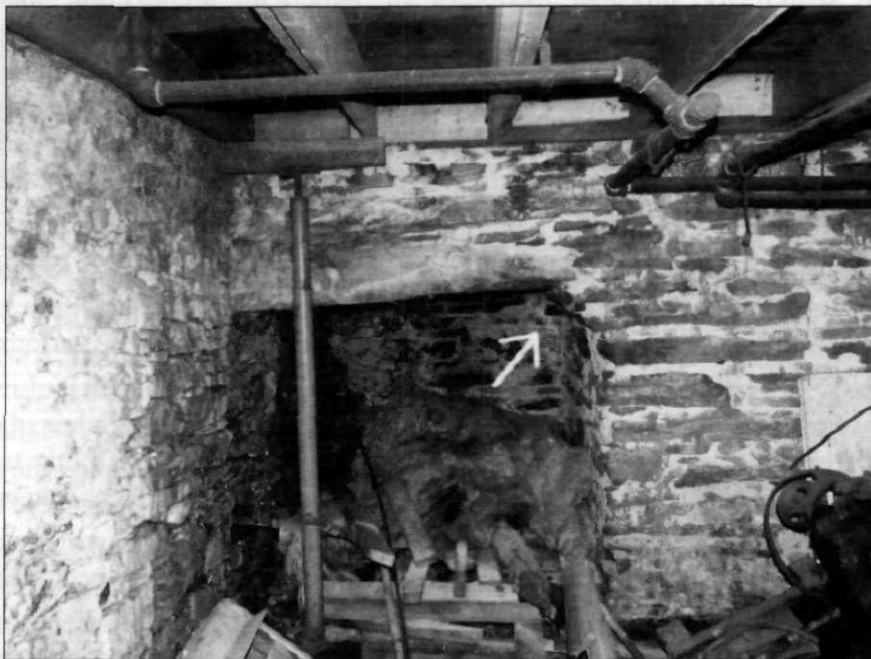
*Figure 8. On the right side, two layers of corbelled stones were used to support the stone slab which was not quite long enough to span the whole distance. 1791 John Park House, Ayer, MA.*

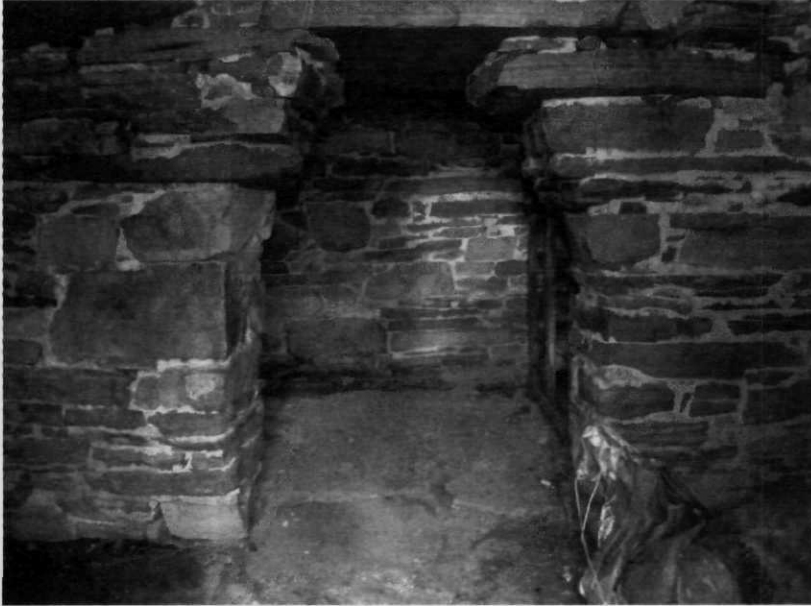
*Figure 9. This root cellar is divided into four rooms by two thick stone masonry walls which double as columns to support the stone roof. Three layers of corbelling are evident at the top of the walls. Spicer Hill Root Cellar, Ledyard, CT.*

structure. It is accessed through a rectangular walk-in height doorway with a single step down to a flagstone floor. The interior is divided into four rooms by two short thick dividing walls that serve as pillars to support a stone slab roof. Both dividing walls have three to four courses of corbelled stones at their ends. (Description based upon published & unpublished photographs by Ted Hendrickson.)

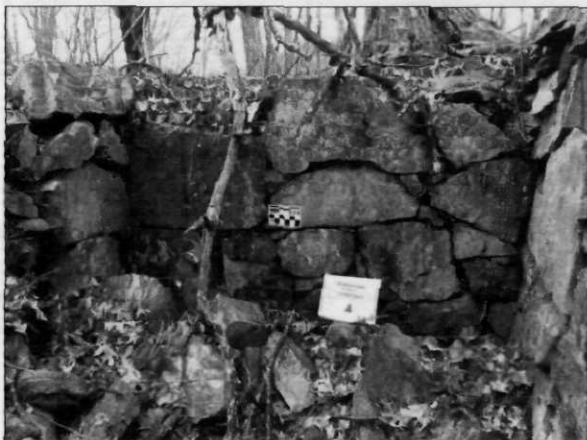
Figure 13. Another wall of the same house foundation showing the common type of flat faced stones used.

Figure 12. House foundation with flat faced walls, square corners, and box-like shape. Georgetown, MA.

The house foundation has an L-shaped layout. It was built with flat faced stones integrated to create a flat wall surface. It has square corners and straight walls (Figures 12 & 13).

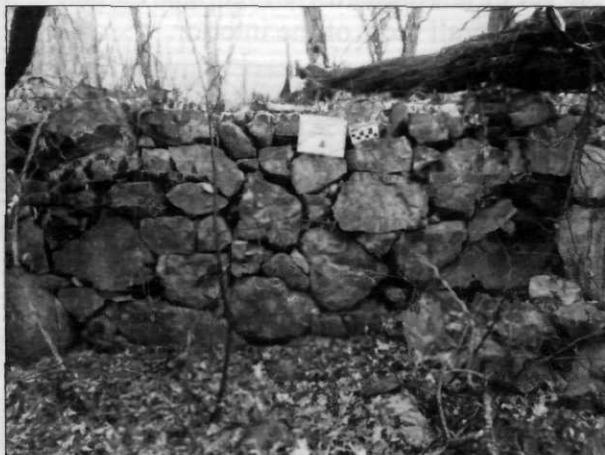
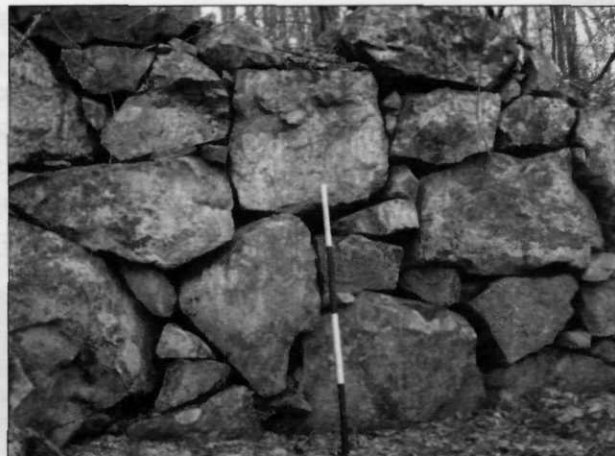
Figure 15. Some of the stones used in the barn foundation were blasted field stone. This foundation stone has a single long blast hole.

Figure 14. Barn foundation has the same characteristics as the house foundation in figs. 12 & 13. The only difference is the flat faced stones are larger. Georgetown, MA.

The barn foundation has a rectangular shape built with extra large stones with the same flat faces, flat wall surface, square corners and straight walls as the house foundation above (Figure 14). In addition, the barn contained blasted stone, as evidenced by the blast hole (Figure 15).

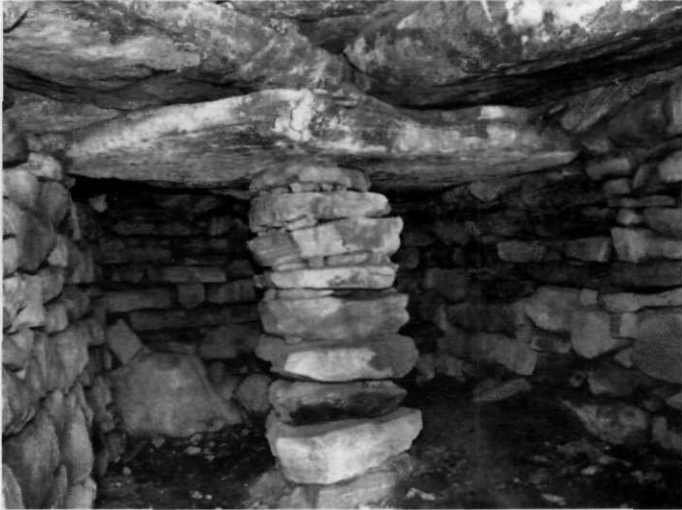
Figure 16. This root cellar has a rectangular room, straight vertical flat faced walls, and square corners. The stone support column is unusual but has been used in some American barns. Ledyard, CT (Photo courtesy of Ted Hendrickson).

This structure has a rectangular or square-shaped room (Figure 16). The interior exhibits vertical walls bottom to top. There is no corbelling. It has flat-faced stones with a flat wall surface, square corners and straight walls. A stone column is visible in the middle photograph, which is a trait found in some American barns. Ted Hendrickson, a professional photographer, arranged a triple set of photographs to highlight the left and right sides framing, the middle and entrance. It gives an overall view of the interior.

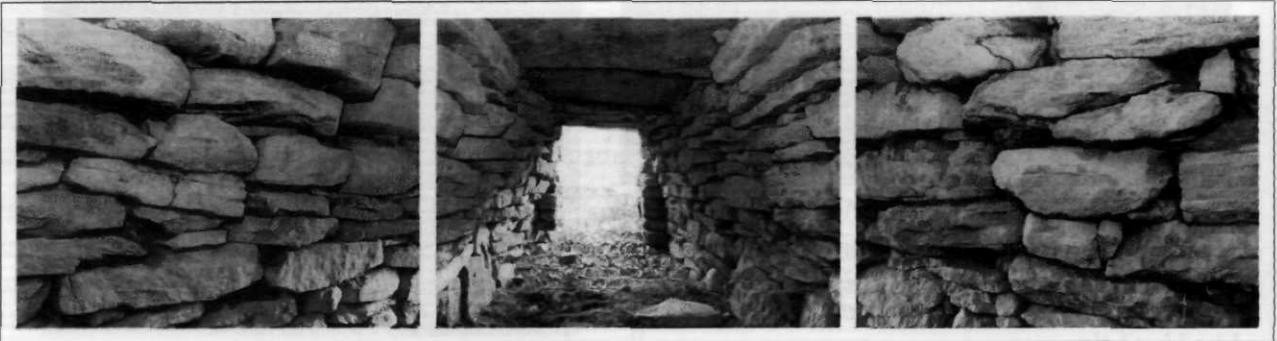
Figure 17. This root cellar has a rectangular tunnel like room with long parallel vertical walls that transition to corbelled near the top. Montville, CT (Photo courtesy of Ted Hendrickson).

This root cellar has long parallel vertical walls that transition to corbelled near the top (Figure 17). The left and middle photographs show the corbelling. The interior shape is tunnel-like, while maintaining a basic rectangular shape. Note the root cellar was constructed with semi-flat stones but still has a flat wall surface and straight walls. The Montville #4 stone structure, like the Park House, indicates farmers also used the corbelling method. Farmers found it useful for narrowing the top width of the cellar to accommodate the length of the stone slabs they had.

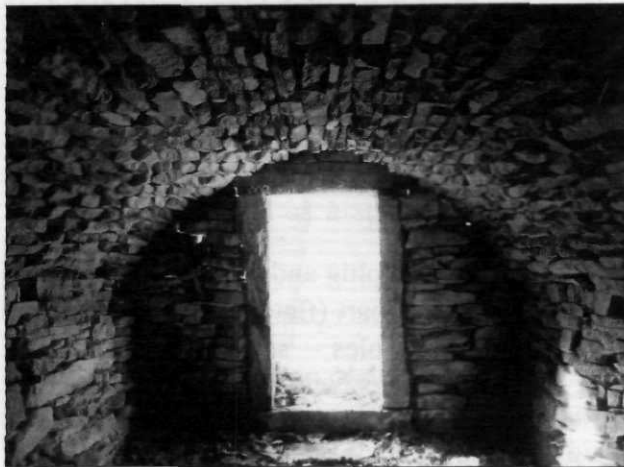
Figure 18. Interior view of the root cellar's stone arch roof made from flat stones. Thompson, CT.

of building arches came over from Europe. They are European in origin and an historic marker. This particular root cellar has a façade of large rectangular granite blocks with flat wedge marks, indicating it was built post-1800 (Gage & Gage 2005: 41-42; Gage & Gage, 2013) (Figure 19). Facades showed up in several other root cellars in Connecticut.

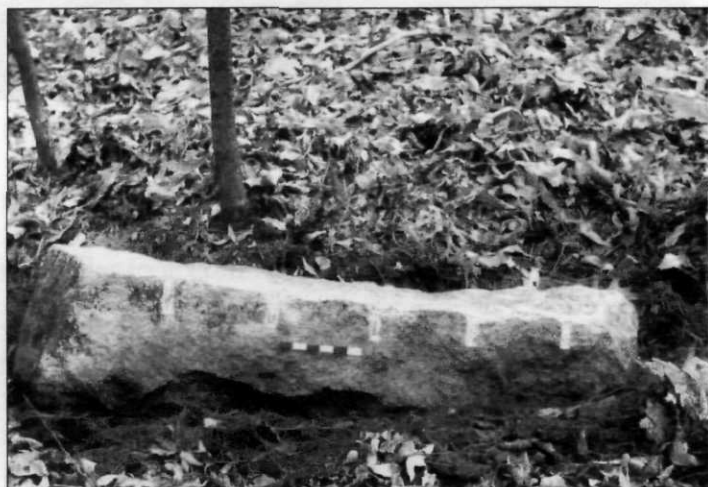
*Figure 21. Trapezoid shaped tool marks from the flat wedge method of splitting stone.*

**Quarry Tool Marks** – Half round drill marks spaced 6-8 inches apart (plug and feather method – see Figure 20), trapezoid shaped flat wedge marks spaced 3-4 inches apart (flat wedge method – see Figure 21), 6-20 inch deep single half round drill marks (blast holes – see Figure 15) are all indicators that a stone was quarried. Blasting was introduced into New England in the early 1740s but not common until after 1800. An early version of the plug and feather method was developed in the 1790s but examples are rare. A commercial version of the method was introduced after 1803 and prior to 1823. The flat wedge method was invented in the late 1790s. These tool marks all indicate a post-1740 and in most cases a post-1800 date for the split stone (Gage & Gage 2005, 2013, n.d.).

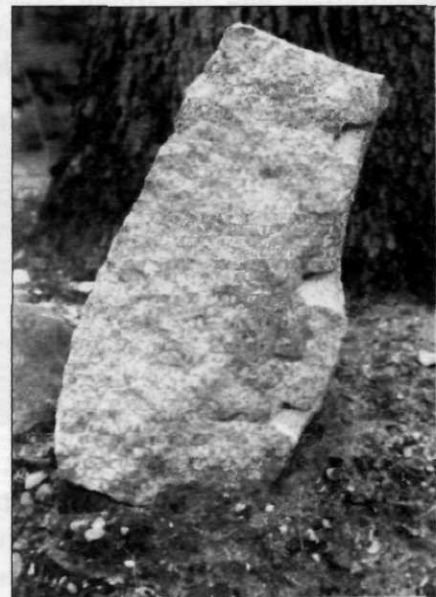
*Figure 20. Quarried stone bar with 3 inch deep half round drill marks spaced 6-7 inches apart created by the plug & feather method of splitting stone.*

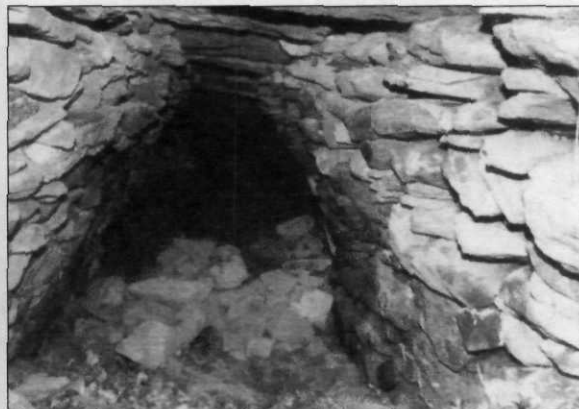
Figure 23. The Pottie Chamber has vertical to corbel walls. Charcoal found just above the roof stones produced a C-14 date of 850 BP +/- 140 years (uncorrected). Newton, NH.

This chamber has vertical to corbelled walls with a roof of six stone slabs (Figure 23). It is 14 feet six inches long, five feet ten inches high, six feet wide at bottom, and two feet six inches wide at the roof. The side walls undulate along their lengths, bowing out in the middle section. The entrance is crawl-in height located midway in the chamber's overall height and goes directly into the chamber. The entrance's placement creates a short drop into the interior.

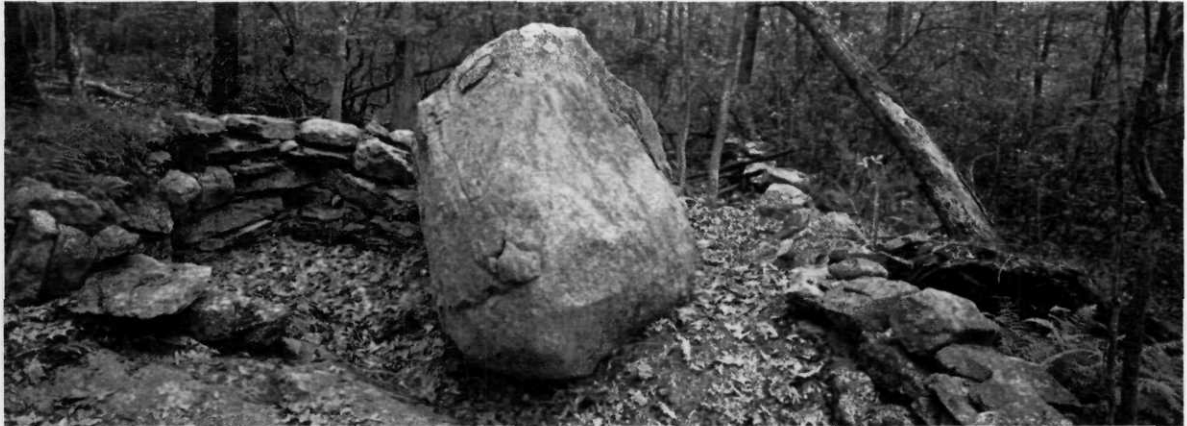
Figure 24. This chamber has a curved interior wall and incorporated a large boulder into its construction. (The three roof stones, not shown, were found nearby.) Gungywamp Chamber #3, Groton, CT. (Photo by Ted Hendrickson, used with permission.)

were used to roof the chamber (Barron & Mason 1994: 20-21). The wall was constructed with irregular stones that jut in and out creating a rough uneven surface.

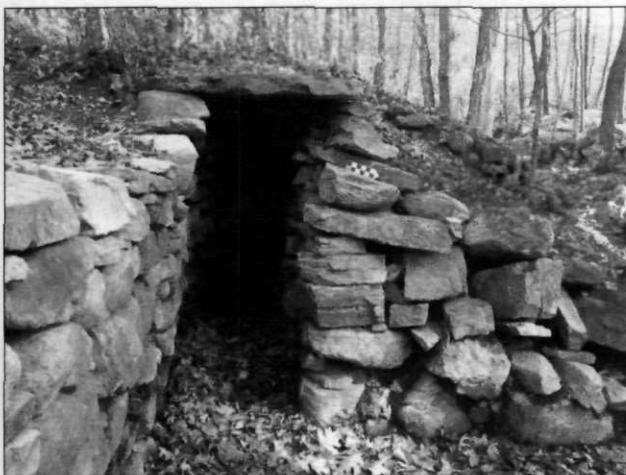
Figure 26. The upper 1/3 of the right wall leans outward. This appears to be an intentional feature rather than structural failure. Stone Chamber, Webster, MA.

The passageway roof slabs are horizontal and show no sign of displacement, which indicates the outward lean of the wall is intentional rather than the result of structural failure (Figure 26). The left side wall has an unusual transition into the interior chamber room. It has two wall sections that jut outward

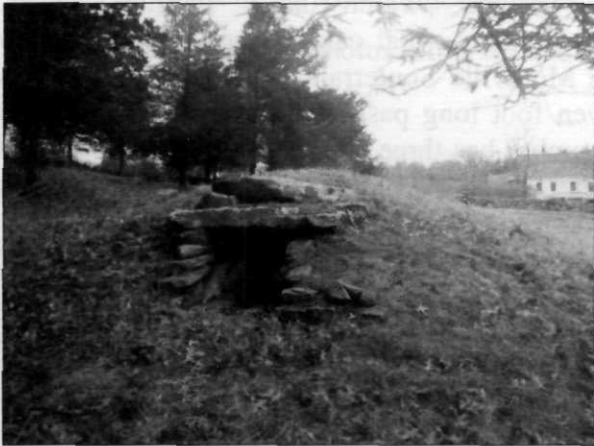
Figure 28. This root cellar is located in a farm field and the farm house is visible behind it. Ledyard, CT. (Photo courtesy of Dan Nelson.)

Group A stone chambers have straight (end to end) flat faced walls and square corners. The walls (top to bottom) are vertical or vertical with some corbelling near the top. The rooms are square or rectangular. The identified root cellars had walk-in or semi-walk-in height entrances, a characteristic that also showed up in some Group B chambers. Overall, Group A stone chambers reflect the historic stone foundations minus the stone roof (for examples, see Figures 28 & 29).

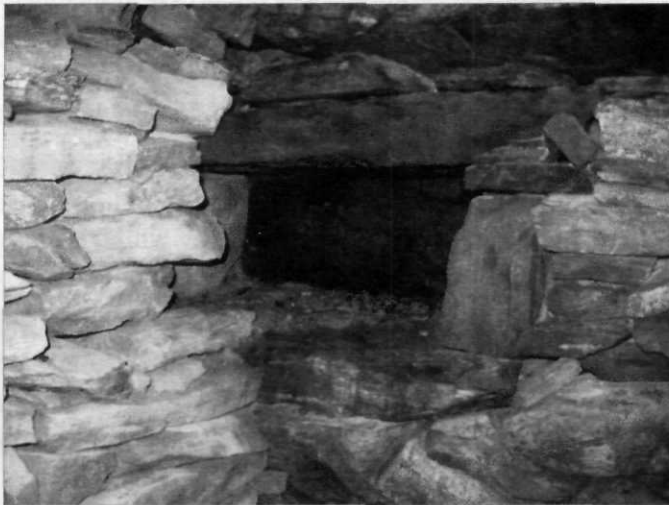
Figure 30. Interior niche in the rear wall of a root cellar. The left hand wall is a 20<sup>th</sup> century addition that divided the original room into two sections. North Grosvenordale, CT. (Photo courtesy of Chris Pittman.)

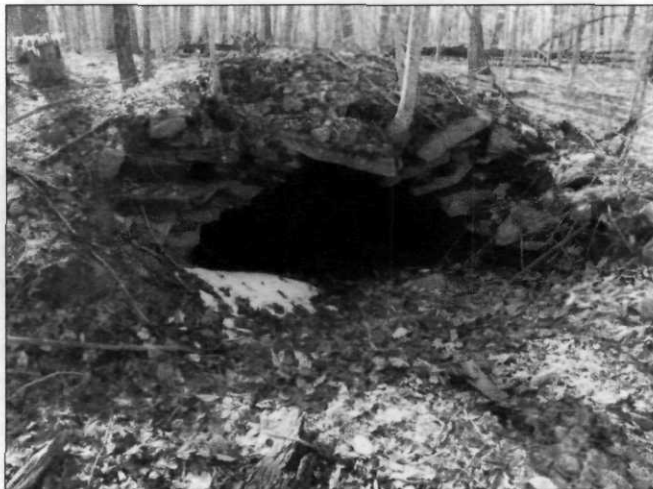
Figure 31. Exterior view of a stone chamber showing the corbelled wall to slab roof design. Hoffman Evergreen Preserve, Stonington, CT. (Photo by Ted Hendrickson, used with permission.)

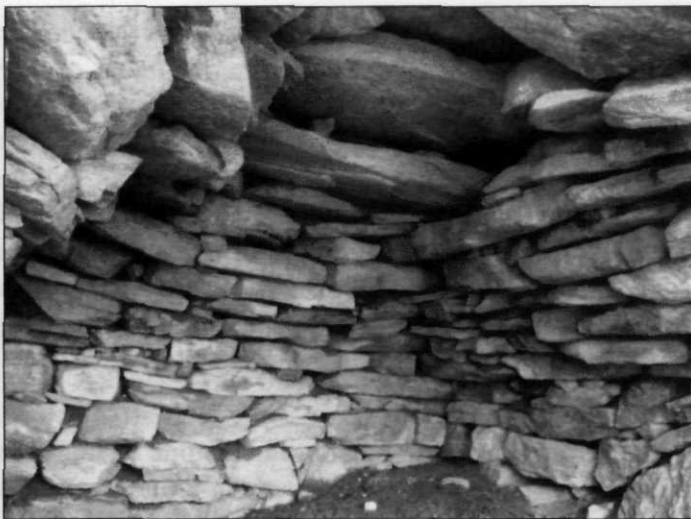
Figure 32. Interior view of the chamber in the Hoffman Evergreen Preserve, Stonington, CT. (Photo by Ted Hendrickson, used with permission.)

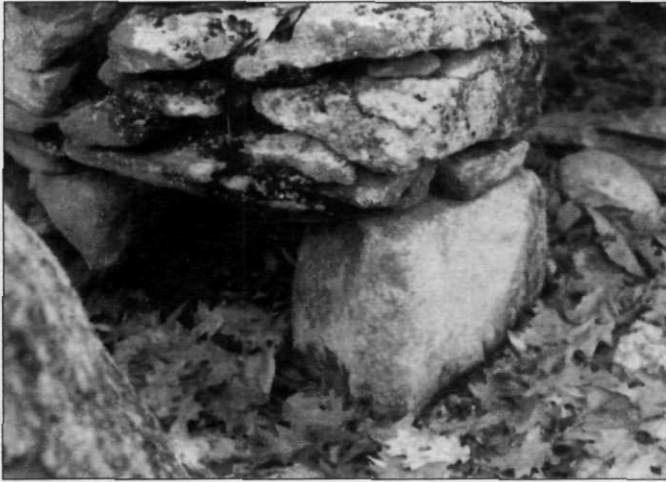
Figure 33. Niche in the exterior wall of the Collapsed Chamber, North Salem, NH.
