Fort Trumbull, New London, CT Constructed between 1839-1852

Visit Wednesday July 21, 2021

Report by Mary Gage with input from James Gage
Photographs by James Gage
Historic images and reports tracked down by James Gage
July 29, 2021

1794 Block House

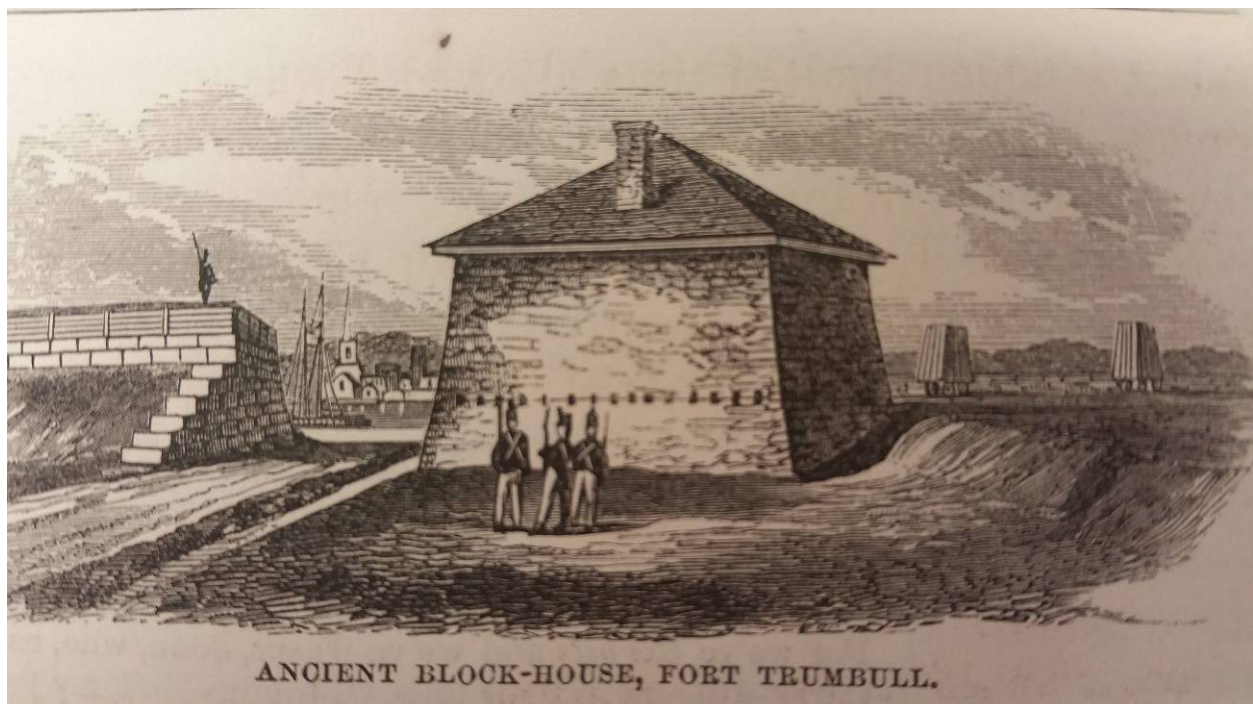
Figure 10 – 1868 illustration of the block house.

An illustration of the block house was drawn for an 1868 book (figure 10). In it the south side is shown along with other nearby features. The south side faced into the fort. The west side with the entrance faced the newly erected retaining wall at the end of a tall embankment across the road from it. The east side had land raised almost up to the rifle ports where two covered canons are visible on the plateau bordered by a low stonewall. The south, west, and east sides rifle ports at that point in time appear to be obsolete yet they were kept open. Only the north side's rifle ports were filled with cement. The north side was the only side vulnerable to a waterside attack and yet its rifle ports were sealed shut.

Is there any information in the data archive about the circular opening? Or the closing of the rifle ports and circular opening?

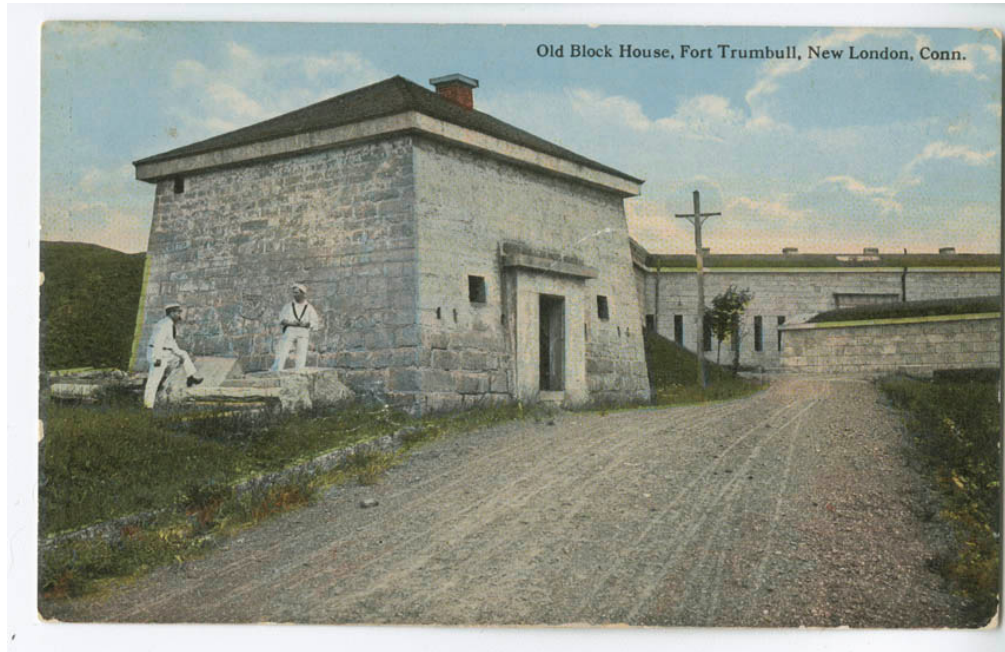
Figure 11 – Circa 1907-1915 postcard view.

A single small square opening is in the top corner under the roof eave in north and south walls. (see figures 2 & 8) West and east side walls do not have the small opening. The openings appears to be for ventilation. The opening is shown in circa 1907-1915 postcard (figure 11). The current ventilator at the peak of the roof is not shown. It dates from later in the 20th century.

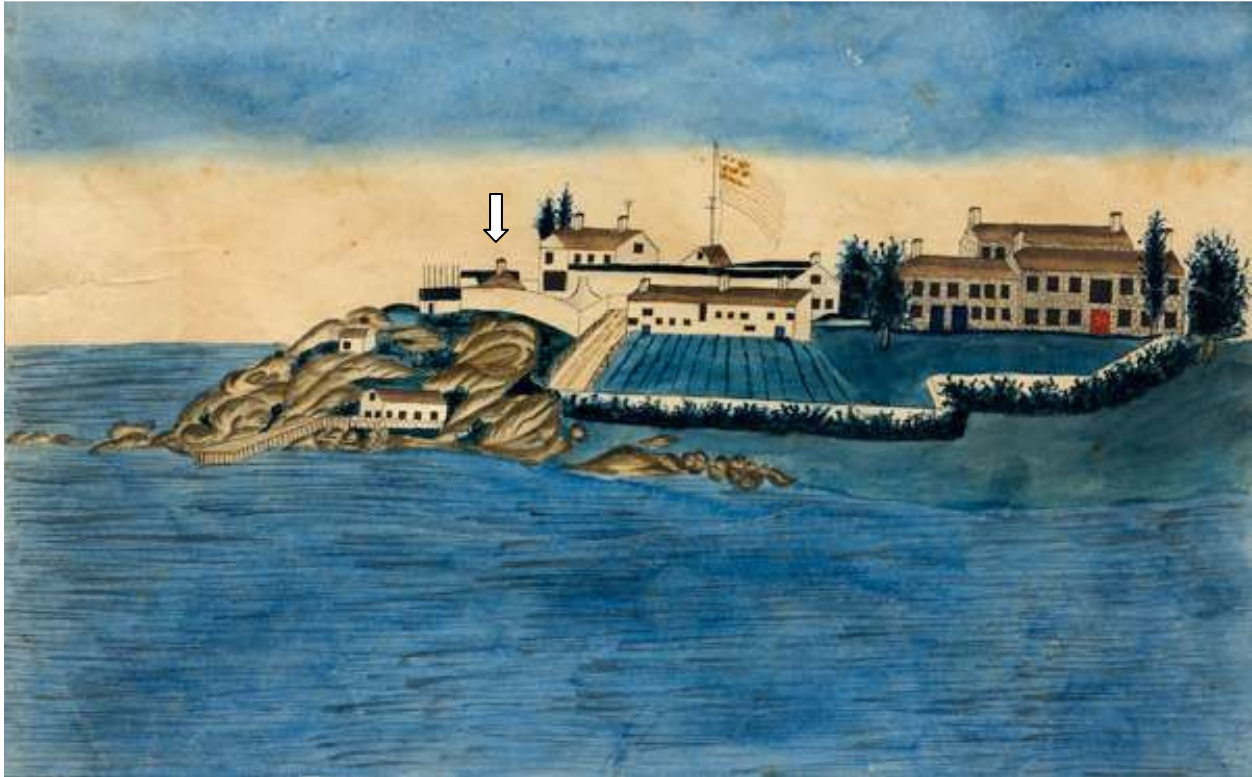
Figure 13 - 1813 watercolor of Fort Trumbull (2nd generation fortification) by an unknown artist. The roof and chimney of the block house are just visible (arrow). New London Maritime Society – Howard Family Collection. Used with permission.

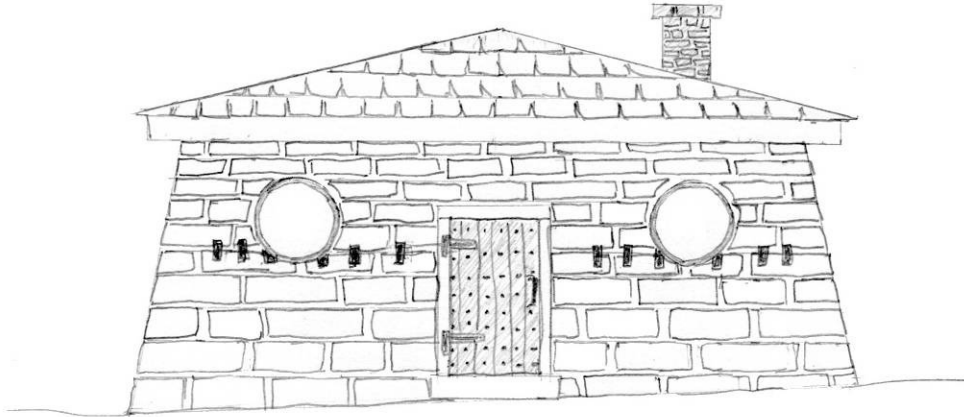
West Side Wall

The height of the original Block House is calculated by the 1st building phase. It is at the top of the bottom half which is currently at the top of the current entrance. The west side had two circular windows flanking a common width wooden door. The north wall had a circular window. Rifle ports were placed around the entire building. The roof configuration may have been the same as is in place currently. The chimney in the block house is shown in an 1813 watercolor of the fort by an unknown artist. The tapered-in configuration of the building is original. It was continued as the building's height was later raised.

Circular windows on west and north sides were the same size.
It is unknown whether the windows had cross bars or other features.
Drawn to scale based upon photographs.
